# ROBBINS LIBRARY

## EXTERIOR ENVELOPE REPAIRS - PHASE 1A BID NO.19-58

COVER SHEET

BID  
DOCUMENTS

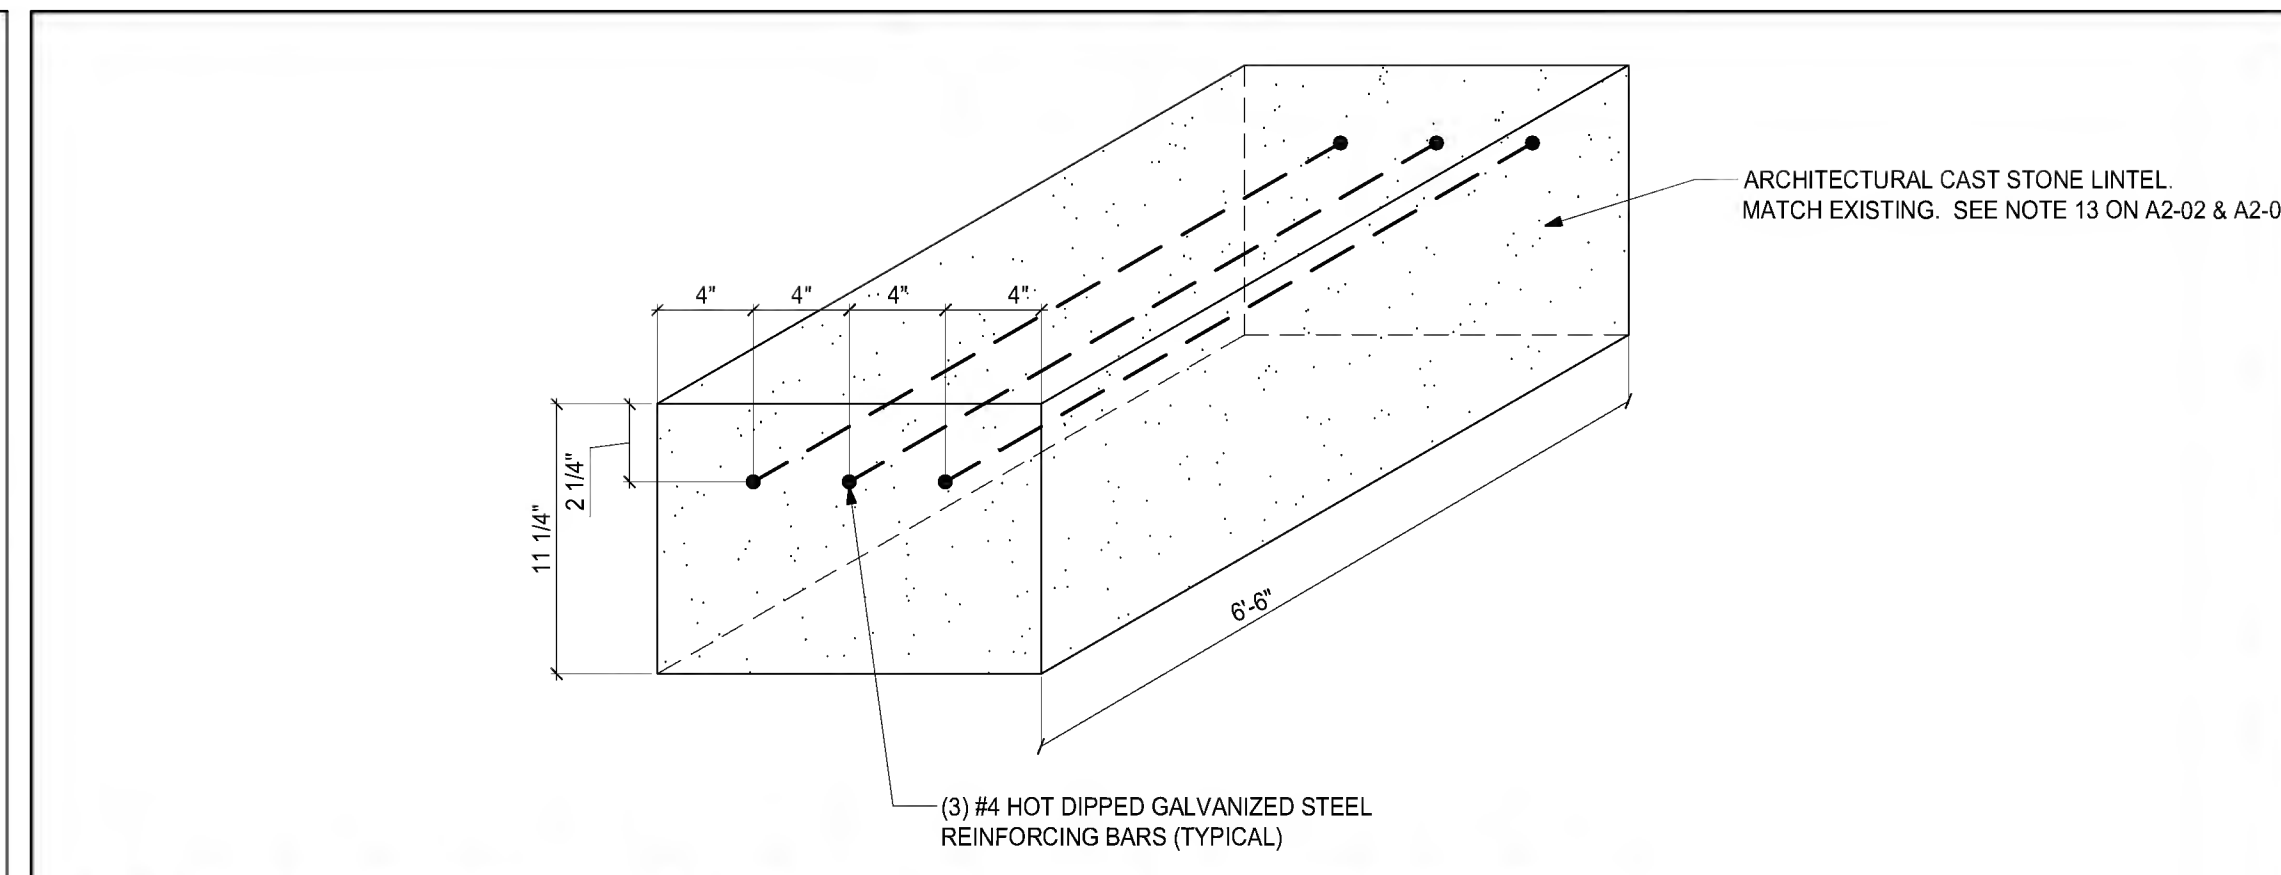
8 ARCHITECTURAL CAST STONE LINTEL ISOMETRIC DETAIL  
SCALE: 1-1/2"=1'-0"

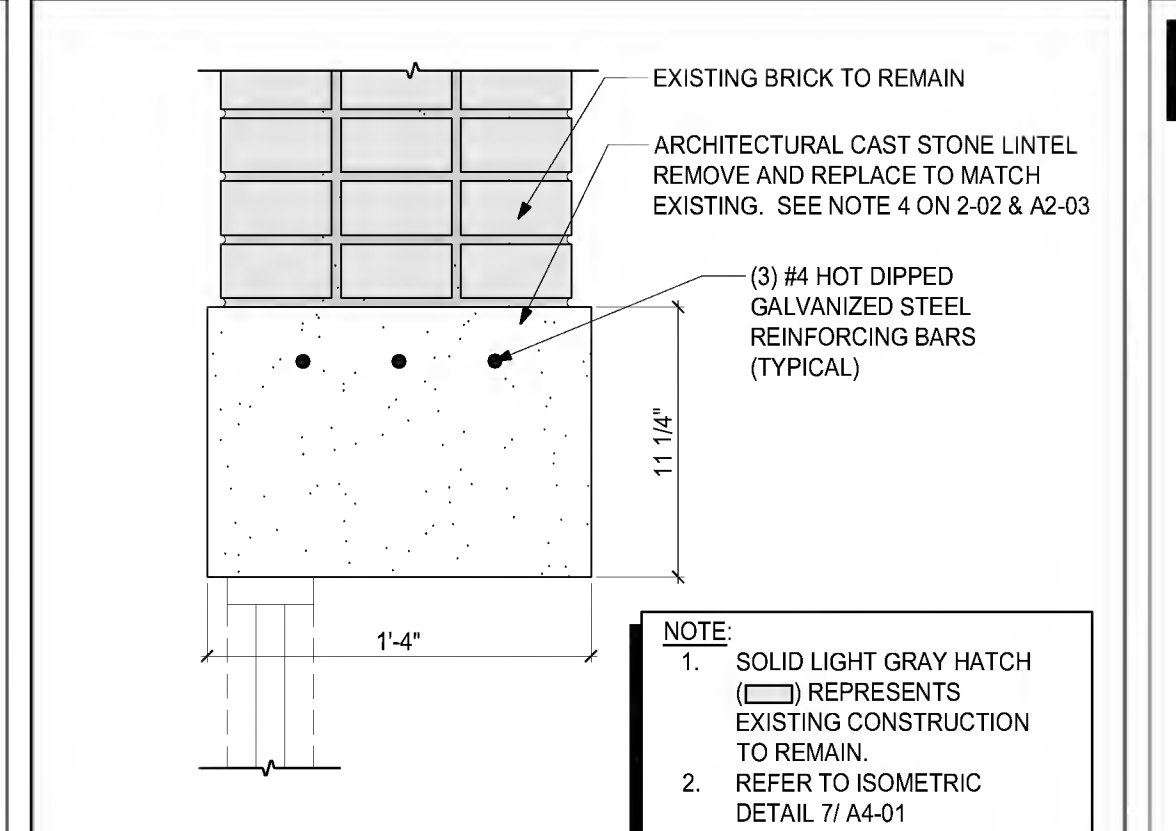
9A ARCHITECTURAL CAST STONE  
LINTEL REPLACEMENT DETAIL  
SCALE: 1-1/2"=1'-0"

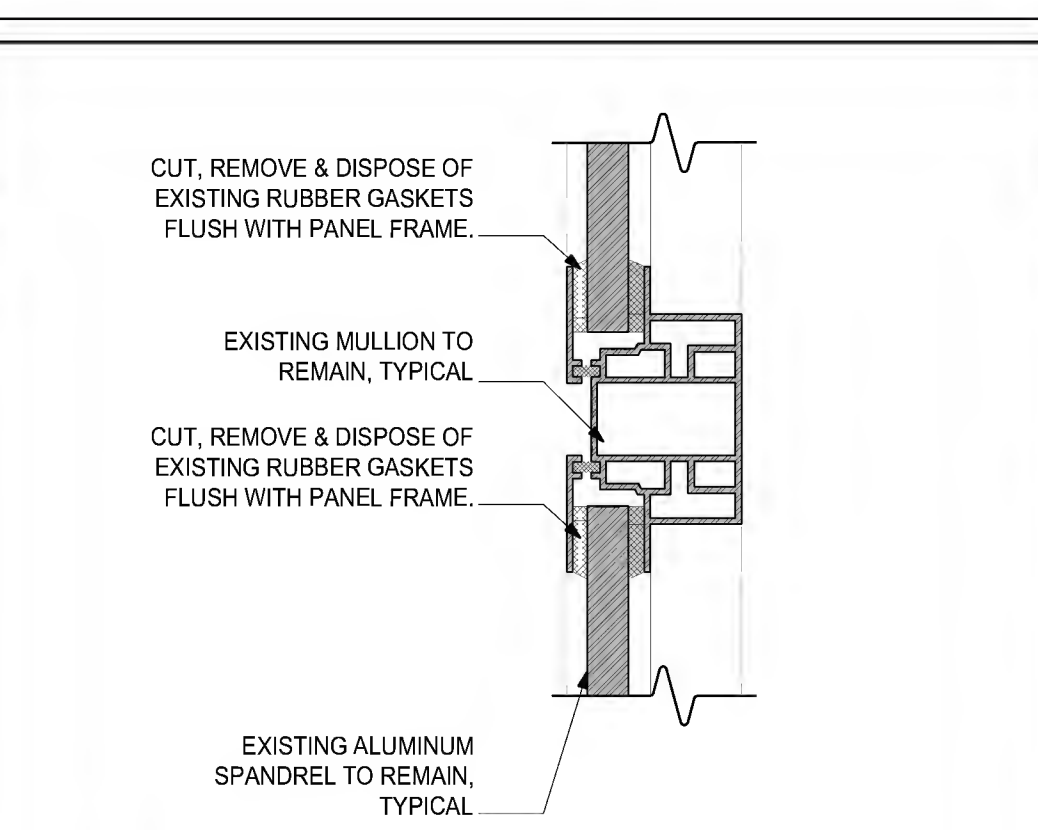
7a ALUMINUM SPANDREL  
TYPICAL DEMOLITION DETAIL  
SCALE: 3"=1'-0"

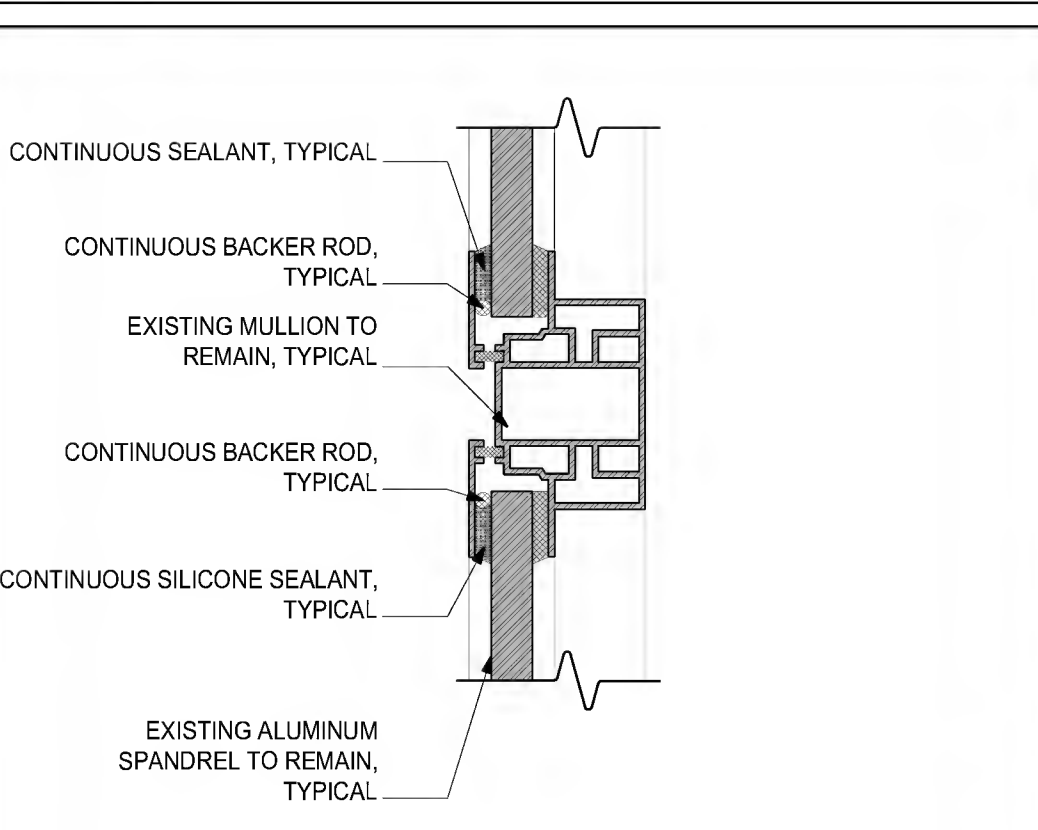
7b ALUMINUM SPANDREL  
TYPICAL DETAIL  
SCALE: 3"=1'-0"

- APPLY NEW BACKER ROD WHERE GASKETS ARE MISSING BETWEEN THE PANEL AND FRAME.
    - CLEAN AND PRIME SURFACES AND APPLY NON-SAG SINGLE COMPONENT SILICONE SEALANT. COLOR TO BE SELECTED BY ARCHITECT FROM FULL RANGE OF CUSTOM COLORS.

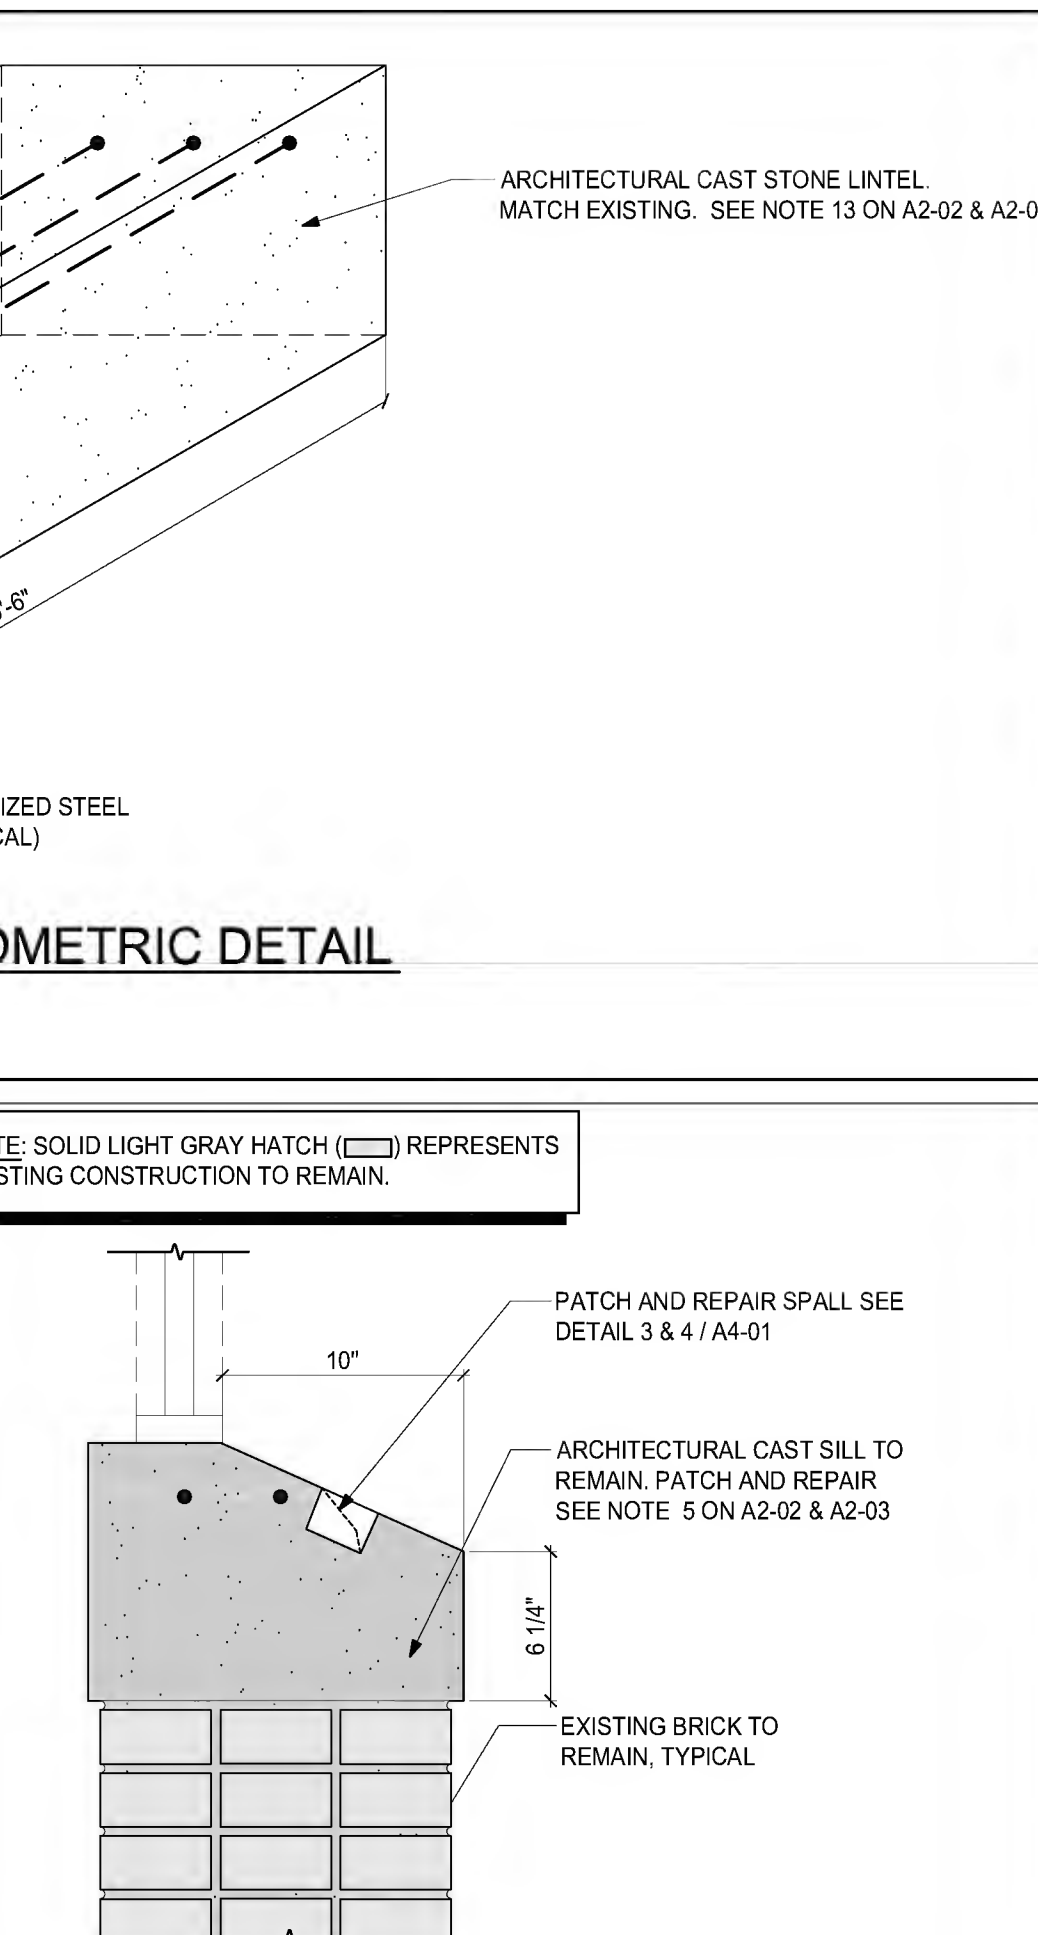
9B ARCHITECTURAL CAST STONE  
SILL REPAIR DETAIL  
SCALE: 1-1/2"=1'-0"

- CUT OUT AND DISPOSE SPALLS, CHIPS AND DELAMINATIONS IN THE ARCHITECTURAL CAST STONE WINDOW SILL. CUT OUT A MINIMUM 1/2" DEEP & SQUARE OFF ALL EDGES. CLEAN SURFACE & APPLY SINGLE COMPONENT, CEMENTITIOUS MINERAL BASED REPAIR MORTAR TOTAL QUANTITY OF 208 CUBIC INCHES IN SELECT AND RANDOM LOCATIONS ACROSS ALL ELEVATION SELECTED BY THE ARCHITECT. REFER TO UNIT PRICE - SPECIFICATION 01 22 00.
